**DEVELOPING AN EVALUATION MODEL OF TIRE/PAVEMENT NOISE****Hawraa Faisal Jabar\*, Dr.Rasha H. Abdul-Amir, Dr.Ammar A.M Shubber**

**DOI: 10.5281/zenodo.1302267****KEYWORDS:** Noise, pavement performance, the effect of distress on noise.**ABSTRACT**

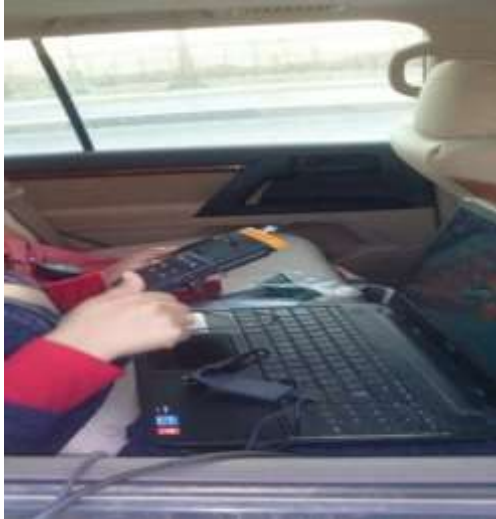
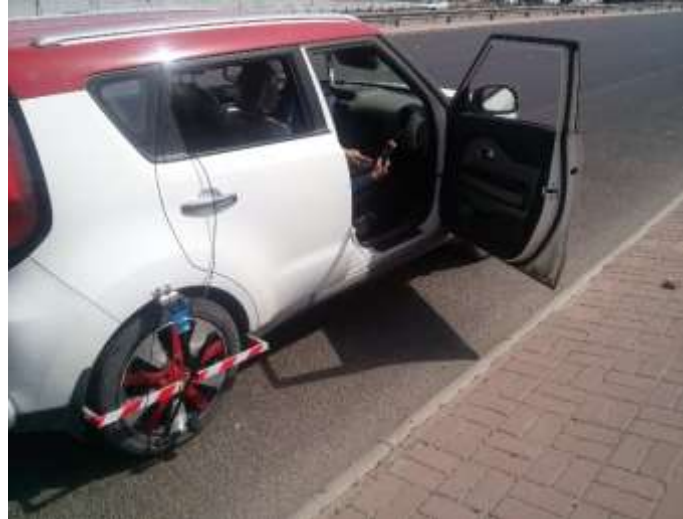
*Figure1 A. sound level meter and standard sound cart.*

*B. The setups of the probes were verified to be within the limits set in TP 76, for height above the pavement, distance to the tire Photograph of the sound intensity measurement fixture installed on the right rear wheel of the test vehicle.*

A method is described in which a sound intensity probe is installed directly on a test vehicle using an appropriate fixture and tire-pavement noise from a standard test tire is measured. Data is acquired over a 440-ft section of pavement at a constant speed. Depending on local conditions and guidelines ([www.illingworthrodin.com](http://www.illingworthrodin.com)) The timeframes for every speed were selected to test 440 ft. (134 m) of the sections according to AASHTO Designation: TP 76 -08(1) Single probe of one microphone are in the OBSI system placed at the right back tire (passenger side). The microphones (see Figure 1) are located at distance (3) inches (76.2 mm) over the pavement surface and (4) inches (101.6 mm) from the side of the tire. The sound intensity is stated in dB and the results are A-weighted. (4)

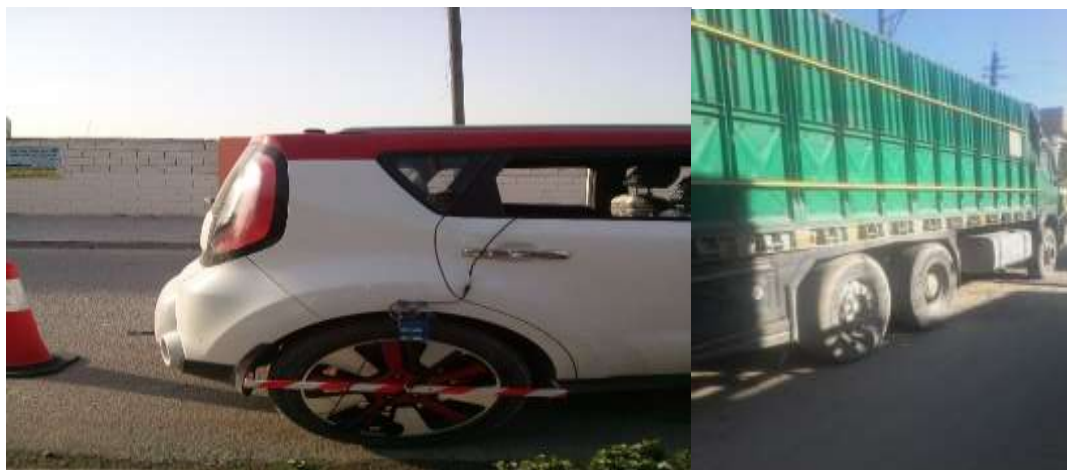
*Figure 2. OBSI fixtures on Kia Soul and Mercedes Benz truck test vehicle.*

- Test Vehicles: figure (2) KIA soul Model 2016 gross vehicle weight 1820 Kg, NEXEN/KUMHO/ TIRE 235/45R18 94V, Mercedes Benz truck 1993 gross vehicle weight 9 ton, Cristone TIRE 315/80R22.5 details in table1

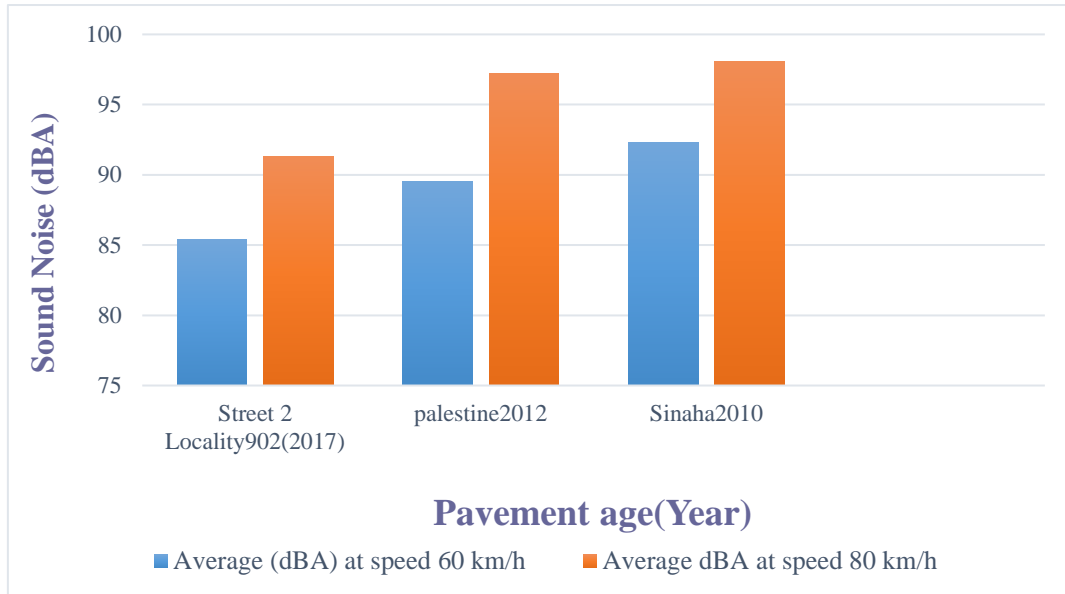
Figure 3. Effect of pavement age on tire/road noise, Baghdad roadway sections.

Figure 3. Presents the tire/road noise levels of the different pavement sections respect to pavement age depending on the speed. As observed, there was an increase of about 2.8 dB (A) from 2010 to 2012 and around 6.9 dBA from 2010 to 2017 at speed 60km/h. while there was increase around 0.9 dBA from 2010 to 2012 and about 6.8 dBA from 2010 to 2017 at the speed of 80 km/h.

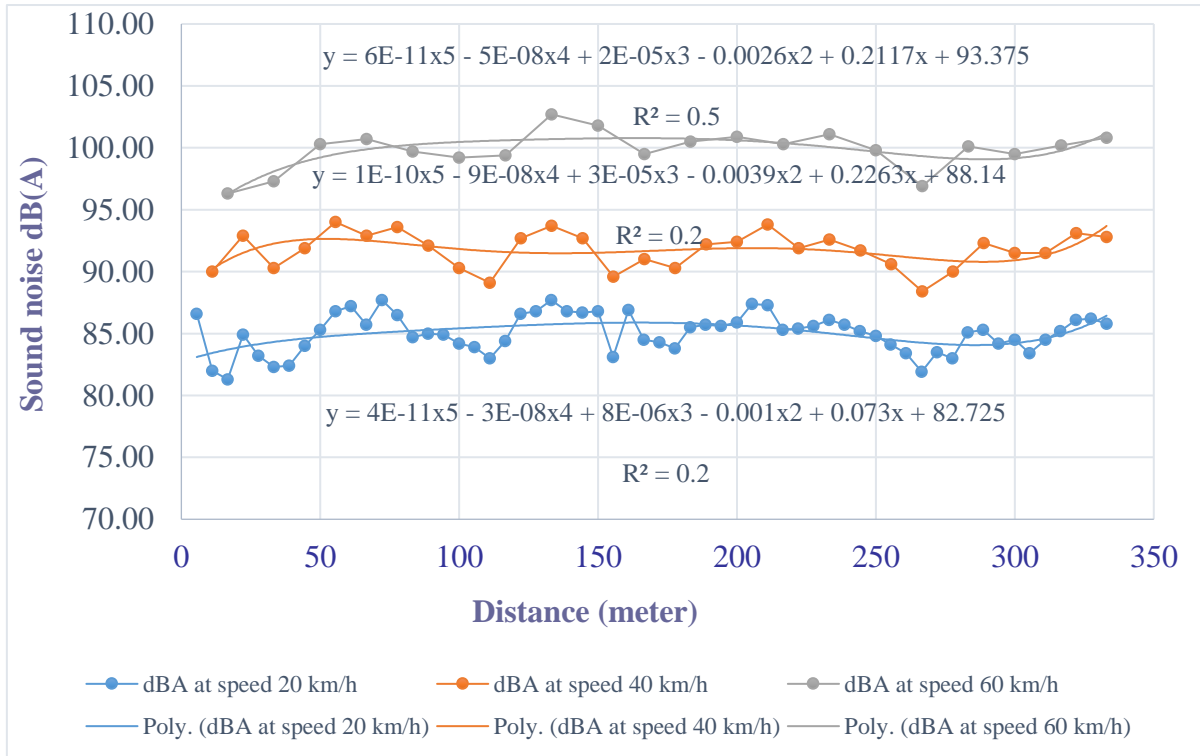
Figure5. On-Board Sound Intensity in AL-Rubaaee street side AL maximal at speed (20, 40, 60) km/h.

As seen in figure 5, 7. Illustrate the variability of the sound intensity over the distance in AL Rubaaee Street in the left lane in two sides maximal side and AL-Kukh side at speed (20, 40, 60) km/h. the noise intensity flocculating all over the distance because of presence cracking, raveling, and failure patching. Figure 5 describes the variability of the sound intensity over the distance. the Test section Started with patching that distance from the beginning to 100 meters there is two peak with value (86.60, 84.90) dBA at speed 20 km/h, distance from (50 to 100) meter, (100 to 150) meter number of peak appear referred to raveling with value range about (87.20-87.70) dBA and this also contains cracking and patching. But the highest level of the noise intensity caused by raveling. These have been insured by visual inspection and these value increase with increasing speed and the variability taking similar in shape for each speed. Figure 7 stated the variability of the sound noise over the distance in AL-Rubaaee street side L-Kukh. The level of the sound intensity as shown in the figure is lower than from the other side as presented in figure 5 AL-Maximal side. The distance started to 100 meter with two peak due to raveling at value (86.40) dBA at speed 20 km/h and this value raised with increasing speed. Figure 8 focuses on the difference between these two sides at speed 60 km/h. we can recognize that AL-Rubaaee at side maximal is higher than at side AL-Kukh in sound intensity dB(A) and that describes the condition of the street from which lane give high sound intensity dB(A ) refers to the bad condition of this lane. However, the similar in pavement type and mixes. While both streets include patching, raveling and cracking there is the difference in Sound Intensity due to having severed cracking, failure patching and potholes.

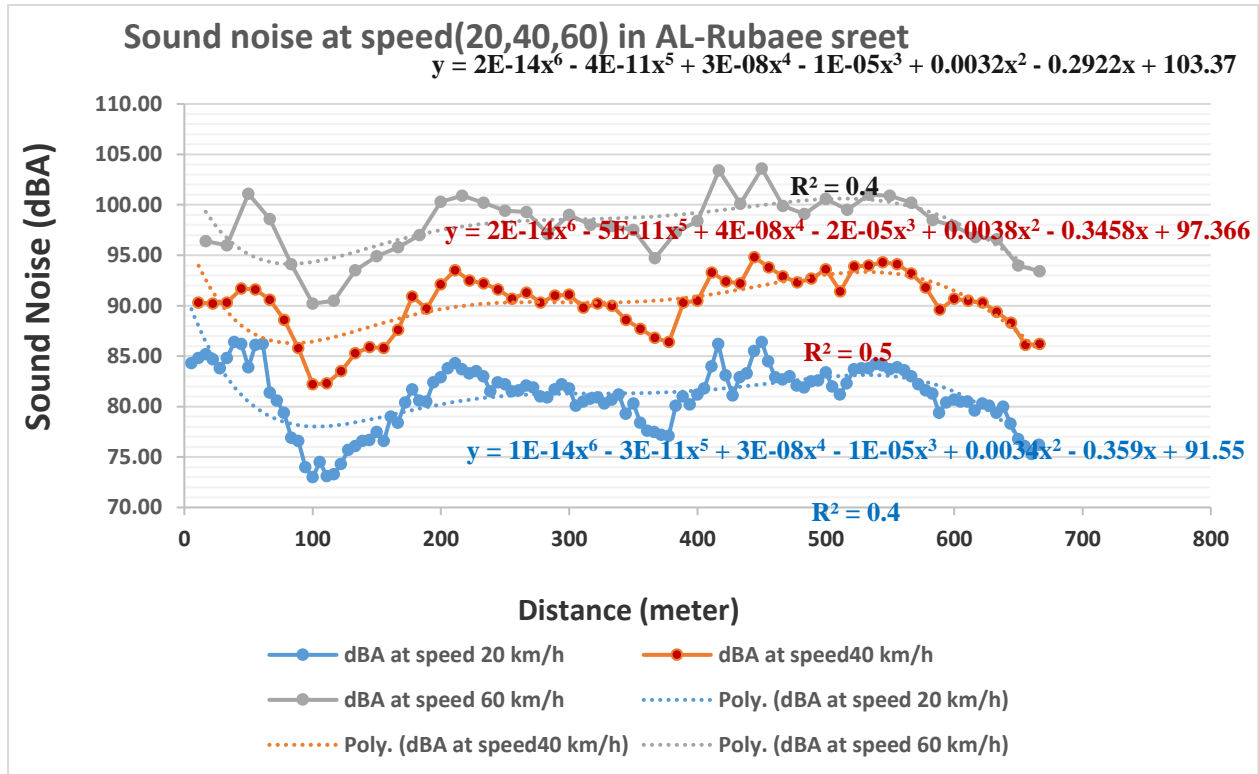
Figure 7. Sound intensity in AL-Rubae street side AL-Kukh Mall presenting variability over the distance.

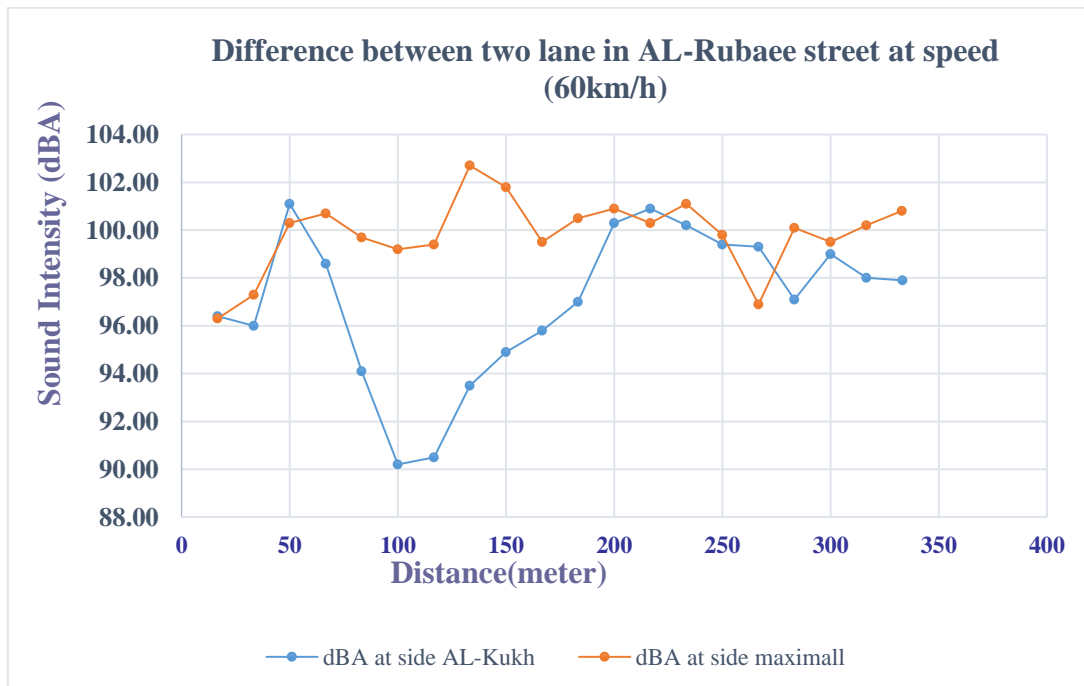
Figure 8. The difference of the sound intensity for two sides in AL-Rubae Street.

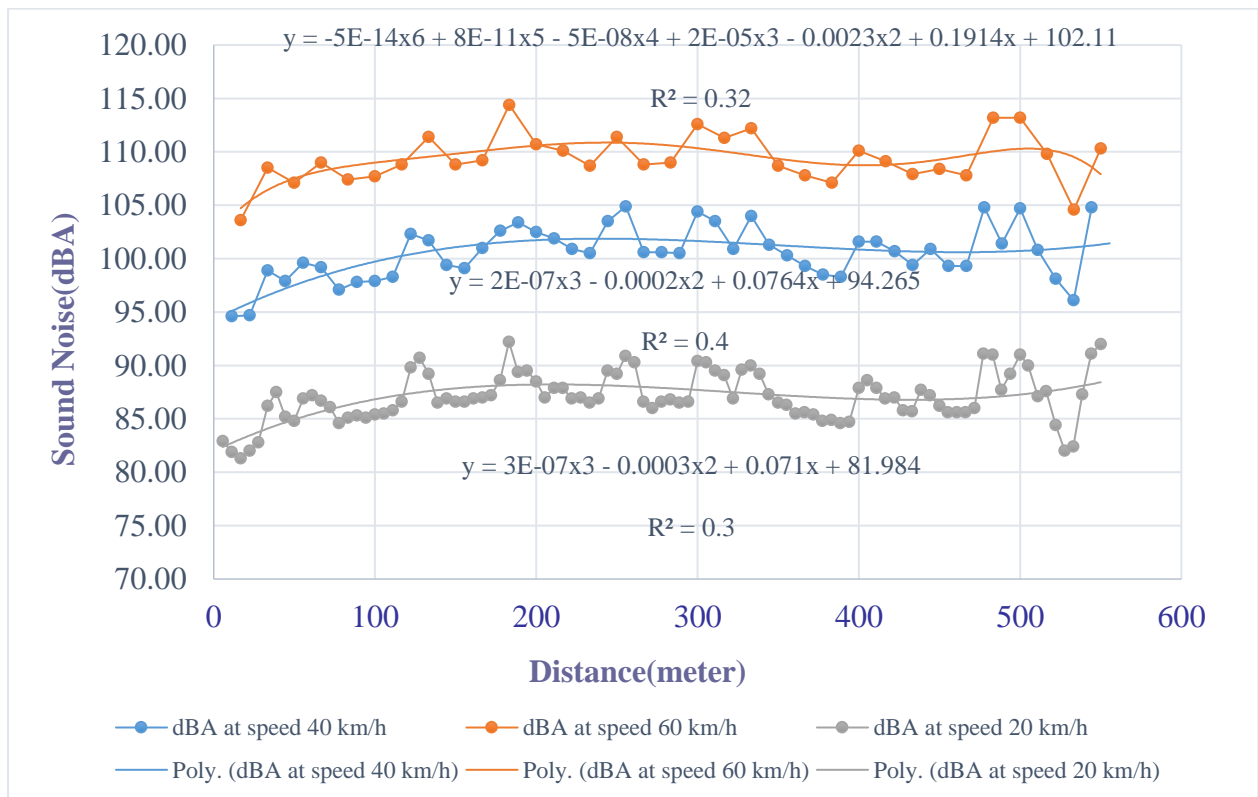
Figure 10. Sound intensity in Mohamed AL-Kassim Road parallels to the University of Technology presenting variability over the distance.

Figure 7. Presenting variability of sound intensity in Mohamed AL-Kassim Road parallel to the University of Technology over the distance at speed (20, 40, 60) km/h

The section contains raveling, potholes, Rutting, the High severity of longitudinal and transverse cracking. To illustrate the effect of these distress on tire/ pavement noise by using the sound level meter as seen in figure 7. The sound intensity level fluctuates all over the distance depending on speed, figure 7. At speed 60 km/h illustrated two peaks below 100 meter due to cracking appear in this area with value (108.5-109) dBA. Also, there is cracking at distance (400, 550) meter with value (110.10-110.30) dBA. respectively, while at distance (133,250,300)meter raveling covered this area with(111.40,111.40,112.60)dBA .the highest level caused by Rutting at distance(183,483,500)meter by(114.40,113,20,113,20)dBA. Respectively.

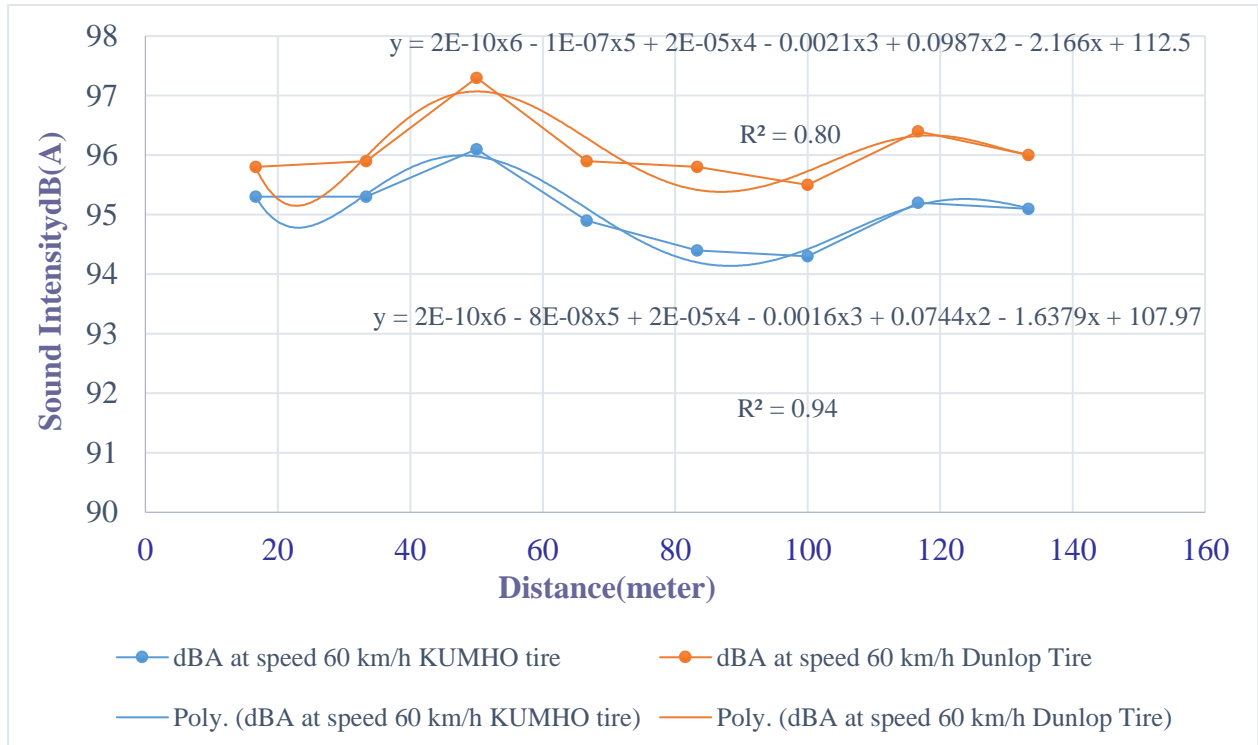
Figure 11. Sound intensity in AL-Fur at Road giving variability over the distance by use tire (235/45R18, 285/60R18) at speed 60 km/h.

Figure 11. Giving variability of Sound intensity in AL-Fur at Road over the distance by use tire (2235/45R18, 285/60R18) at speed 60 km/h. the test section 440 ft. (134.2) meter the right lane from the road. The figure illustrates the difference between two tires passing the test section in this test the difference is very clear and sound intensity take the same shape for speed (60) km/ h. Figure 12 stated that the difference between Dunlop tire and Kumho tire by about (1) dBA at speed (60) km/h. while the difference for the Dunlop tire for the same test section at speed (40, 60) km/h is equal to (3) dBA and Kumho tire at speed(40,60)km/h. similarly, Figure14. Focuses on the changing of noise intensity over the left lane from AL-Fu rat at the road. By visual inspection the test section includes patching, cracking and raveling. For each speed (60,80)km/h sound intensity measurement Fluctuate all over the section due to cracking and patching existing in this area that is followed with sharp rise at distance(400)meter continued to distance( 444) meter making a peak at distance (422)meter with value (120.40)dBA because of raveling came after the failure patching.

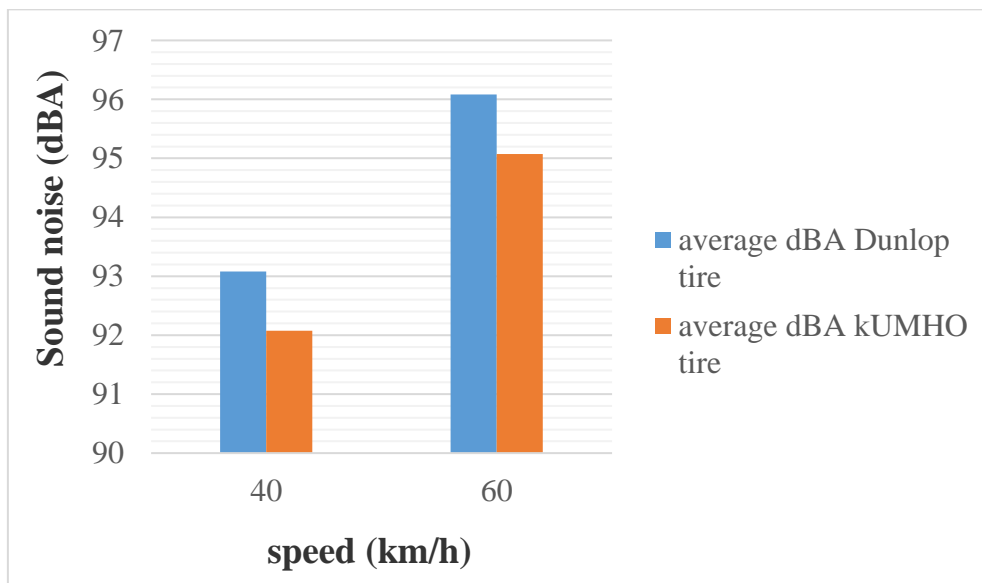
Figure 12. The difference of Sound intensity versus speed by use tire (235/45R18 and 285/60R18) at speed 40, 60 km/h in AL-Fur at Road.

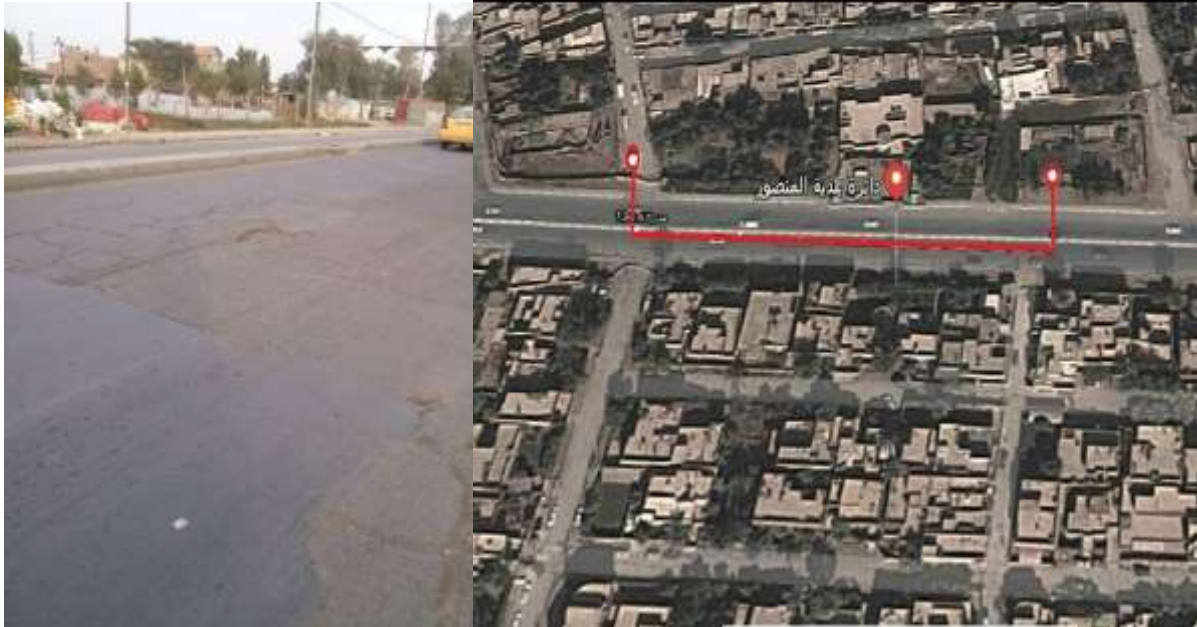
Figure 13. Sound intensity in AL-Fur at Road

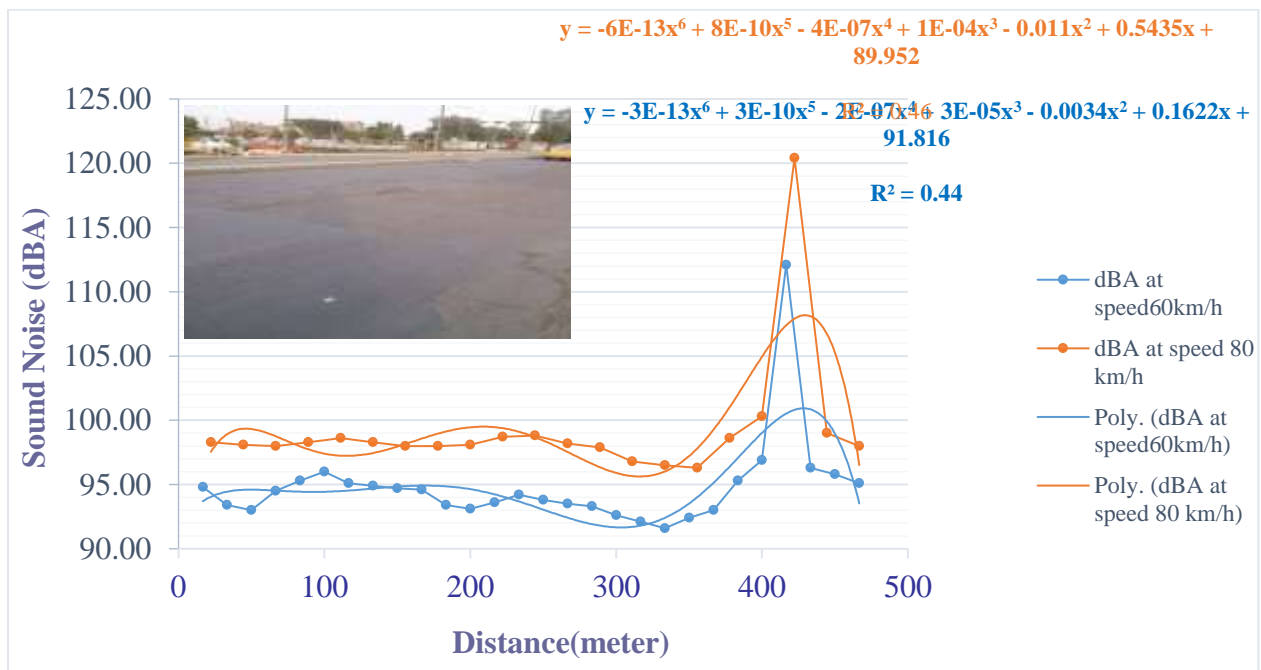
Figure 14. Sound intensity in AL-Fur at Road giving variability over the distance by use tire (235/45R18) at speed (60, 80) km/h on the left lane.

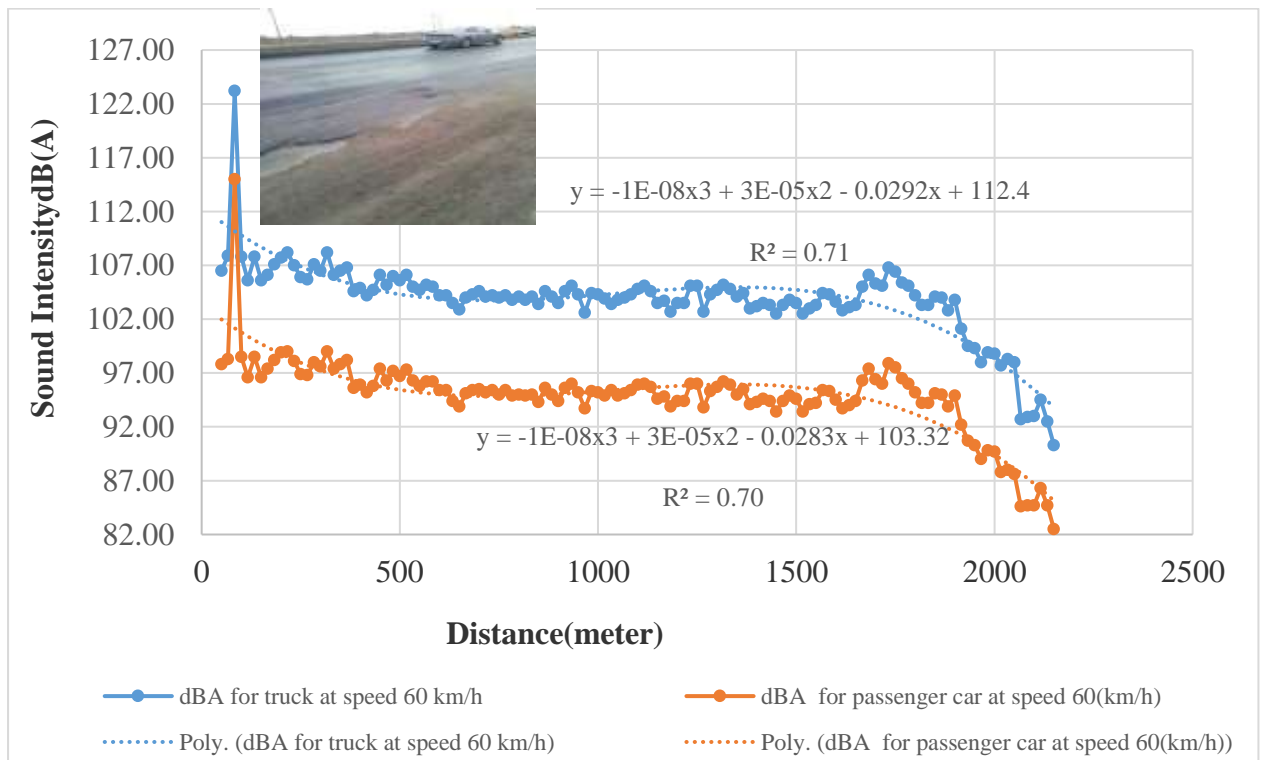
Figure 16. Onboard Sound intensity level with distance showing variability over the test section at speed (60) km/h by using passenger car and truck in AL-Mahmodia Road.

Figure 16. Showing variability of Sound intensity level with distance over the test section at speed (60) km/h by using passenger car and truck in AL-Mahmodia Road. The test section about2000meter. the sound intensity started with severe increase at distance 83 meter due to raveling covered this area established on manual observations with value 115 dBA for passenger car tire (235/45R18) and 123.20 dBA for Truck tire (315/80R22.5).the results are in line with previous research and Reflects a lot of tests," traffic noise prediction methods assign around 6-10 dB (A) higher noise levels to trucks than to typical cars". Often, "an experimental base says that a heavy truck is 10 dB (A) "noisier" than a car is used" [2]. The load of the truck compared to that of a car also makes it natural to think of those lines. In addition. Tire the width is a very influential factor [2] (Walker and Williams, 1979) experimentally measurements the influence of tire width on tire-pavement noise, indicating that there is a clear increase with tire width increasing [3] Figure 17. Elucidate different street at speed 60 km/h. tire type 235/60R18 The level of sound intensity and variability in new pavement street 2 Locality 902 resurfaced at the end of the year 2017 is very low compared to another street. For the same type of pavement. The highest dBA at Muhammad –AL-Kassim street parallel to the University of Technology takes the first degree installed in year2008. As the later contain distress such as raveling, Rutting and cracking .according this we can classified these test section from worst to best condition and identified the priority or which section need for maintenance.

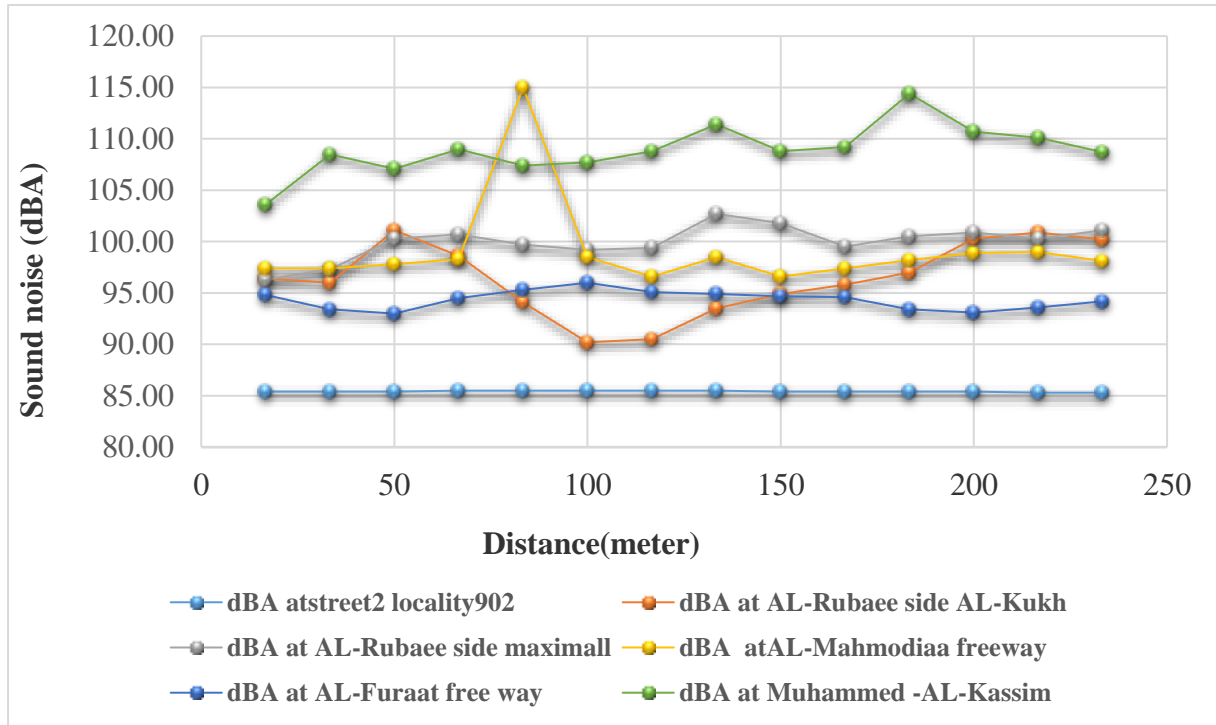
Figure 17. Illustrate compared between different street at speed 60 km/h. tire type 235/60R18

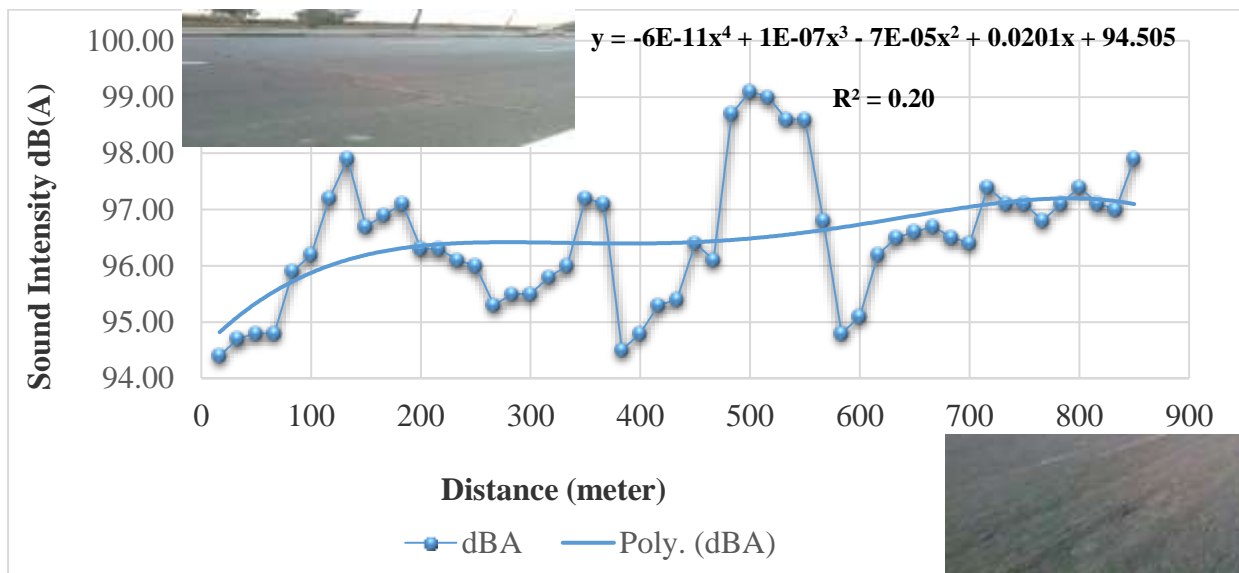
Figure 18. Onboard Sound intensity level with distance presenting variability over the test section at speed (60) km/h use tire (235/45R18) in the Right lane of 14 July Road.

Figure 18. Explained sound intensity for 850 m at 14 July street tire type235/45R18 at speed 60 km/h test section start from the intersection of Damascus the Right lane. It can be noticed that at distance 50 meters there is a slight increase in Sound Intensity (dBA) about 94.8 and followed with sharply raise at a point over 100 meters As results of cracking covered this area.

Overall, violent fluctuate over the distance that is happening as a result of longitudinal, transverse cracking and raveling, besides, they were at their highest at 500 meters while the weakest at beginning of the section [6]
